**HIGHWAY  
RESEARCH RECORD**

Number	Design of
343	Traffic Safety Barriers
	10 Reports

**HIGHWAY RESEARCH BOARD**

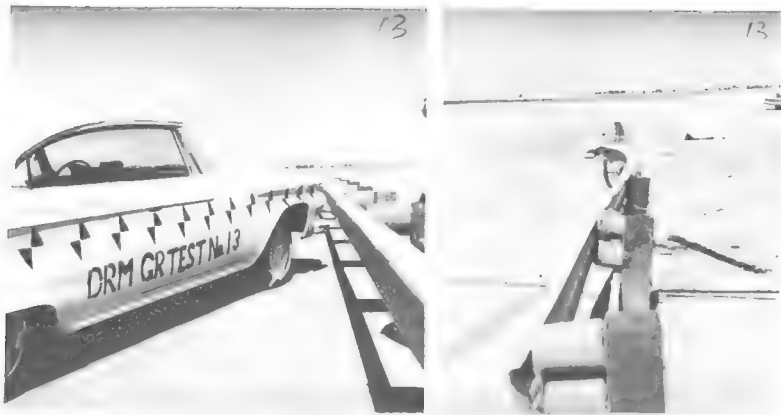
Figure 1. Guardrail system before and after 55-mph, 28-deg impact.

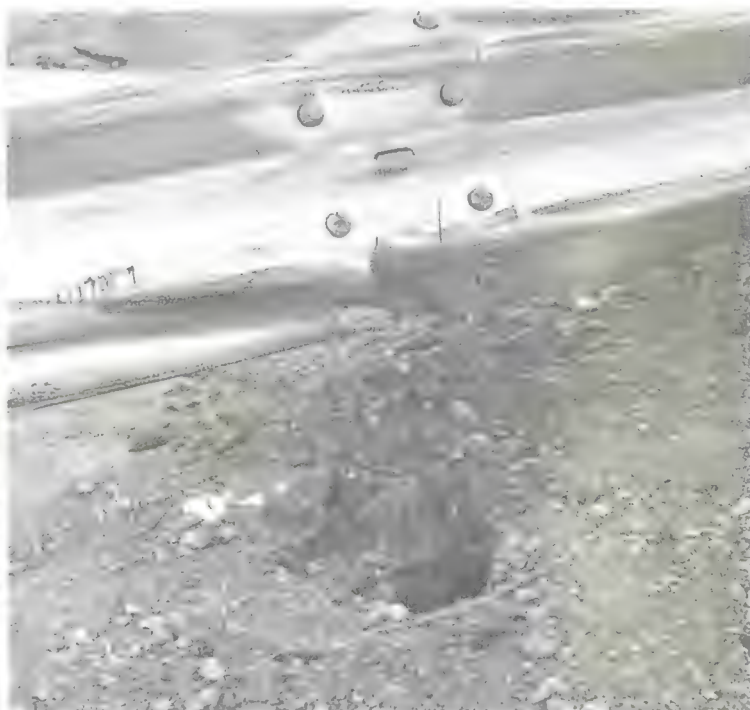
(c) Typical post failure (note tear in rail section)

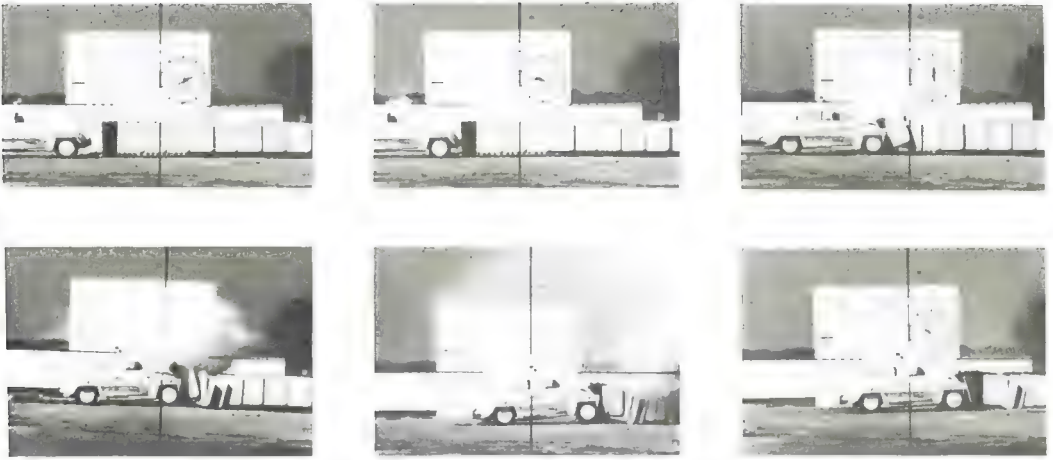
Figure 3. Sequential photographs of Test A.

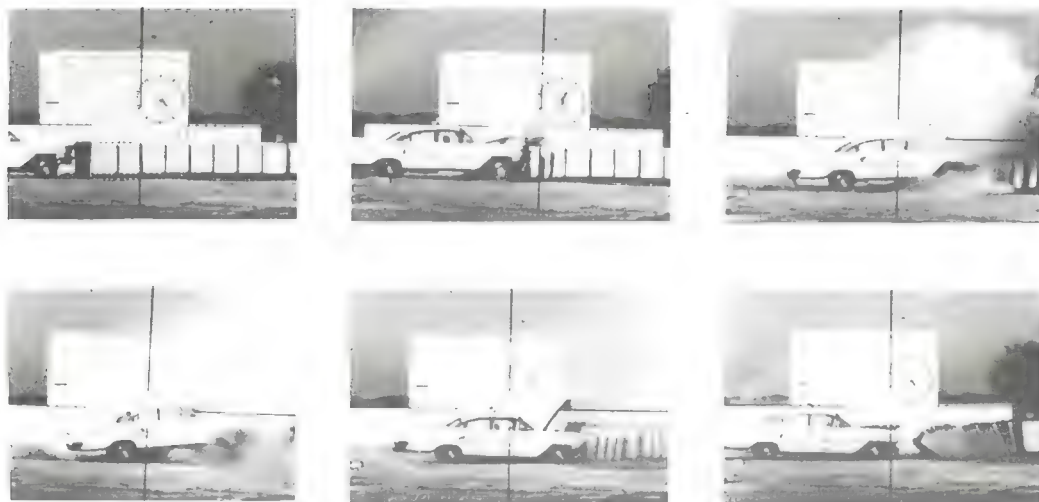
Figure 5. Sequential photographs of Test B.
